AIR LINE PILOTS ASSOCIATION, INTERNATIONAL

In accordance with the Board's rules, the Air Line Pilots Association (ALPA) submits the following comments concerning the aircraft accident involving Alaska Airlines Flight 261, which occurred on January 31, 2000 off the coast of Port Hueneme, California.

**SUBMISSION OF THE
AIR LINE PILOTS ASSOCIATION
TO THE
NATIONAL TRANSPORTATION SAFETY BOARD
REGARDING THE ACCIDENT INVOLVING
ALASKA AIRLINES FLIGHT 261
NEAR PORT HUENEME, CALIFORNIA
ON JANUARY 31, 2000**

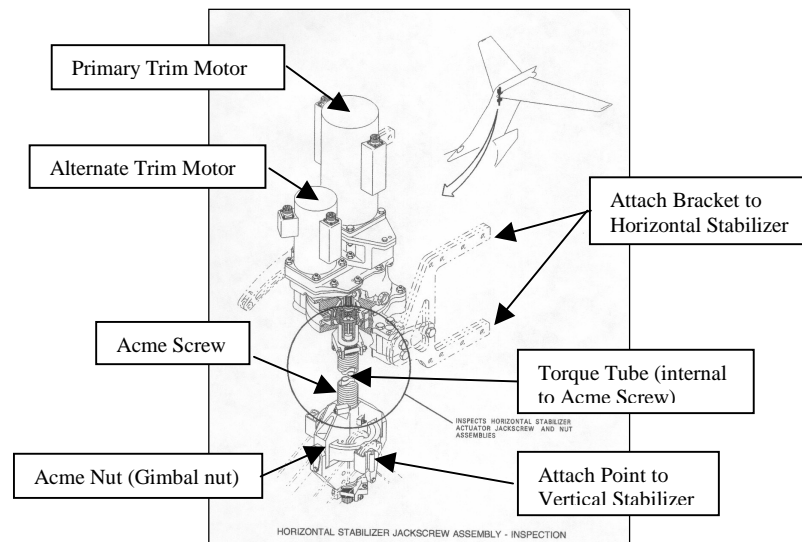
The longitudinal trim actuating mechanism is located within the vertical stabilizer forward of the horizontal stabilizer front spar. The actuating mechanism consists of an Acme screw and nut, drive torque tube (quill shaft) located inside the Acme screw, a main gearbox, a sandwich gearbox, a primary longitudinal trim actuator motor, alternate longitudinal trim actuator motor and the necessary supports. The Acme nut (gimbal nut) is attached to the empennage structure by an Acme nut gimbal ring and retaining pins. The Acme screw is threaded in the Acme nut and attached to the upper support through the gearbox assembly, which is installed at the horizontal stabilizer front spar center section.

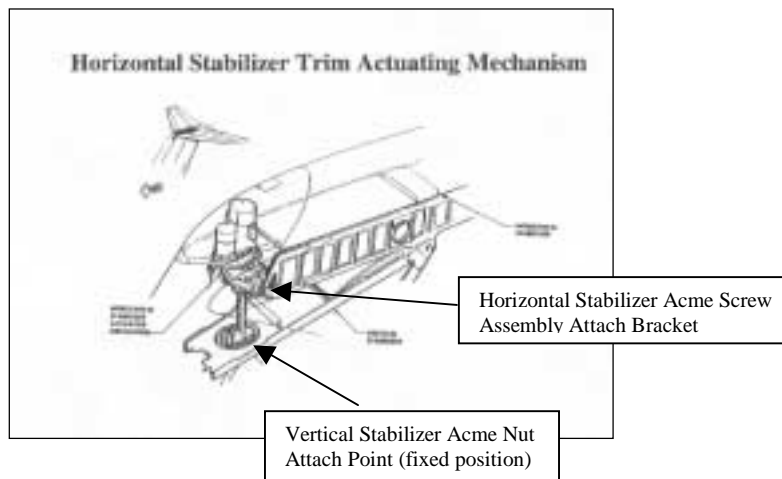
When either the primary or alternate trim motors are actuated, the gear system is driven and the Acme screw is in turn driven through a spline interface between the torque tube and the interior of the Acme screw. The Acme screw therefore rotates within the Acme nut. With the Acme nut being fixed to the vertical stabilizer internal structure and the screw being attached to the horizontal stabilizer structure, the stabilizer is in turn moved up or down based upon the direction commanded by either the flightcrew or the autopilot.
